SUBJECT: A construction laborer died when he was struck by a fast moving vehicle as he crossed the roadway in a street construction work zone

SUMMARY
California FACE Report #04CA008

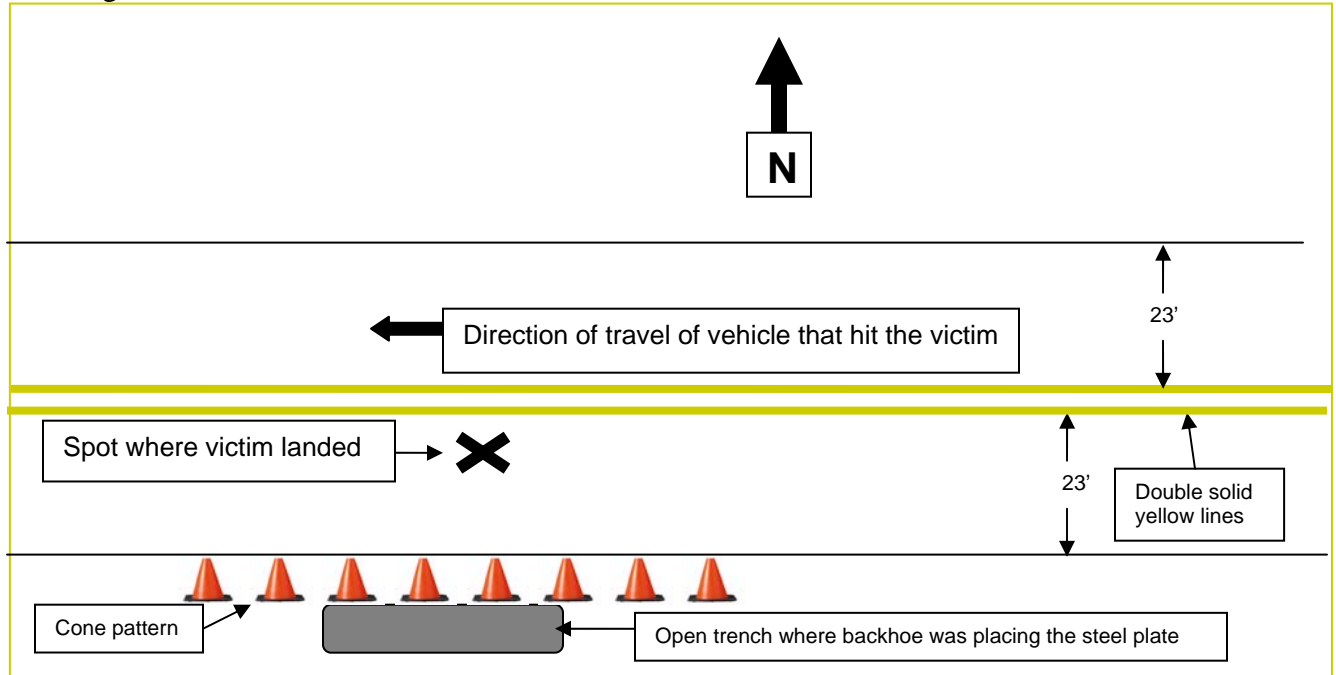
Drawing of Incident Scene

The site of the incident was an asphalt paved avenue that ran in an east-west direction. The company was contracted to replace a water line three feet deep that connected to a main water line. The water main lay on the south side of the avenue, and most of the work was done on the southern shoulder of the eastbound lane. On the day of the incident, sunset was at 5:50 p.m., and the weather was wet with a light rain falling all day. There were two streetlights on the north side of the avenue which were not operating. The avenue had one non-illuminated sign at each end of the work zone stating that there was a construction work zone ahead. It did not warn that traffic may come to a halt. It did not announce a reduced speed for the work zone. The posted speed for the area was 40 mph. There were traffic cones along the southern edge of the eastbound lane. A flag person stood at each end of the work zone to slow traffic, and to stop it when necessary.

The job had taken longer than anticipated and it was dusk by the time the crew began to finish up by placing steel plates over the open trench using a backhoe. The foreman on the job told the victim he was through for the day and that he could go home. The victim began to walk north across the avenue to get to his vehicle. He was entering the westbound lane within the still active work zone when he was struck by a westbound sports utility vehicle (SUV). The victim's co-worker, who was the flag person at the east end of the work zone, saw the SUV coming down the avenue from the east. He stated he waved the stop sign and whistled at the SUV but it did not stop. Another laborer working as a flag person on the west end of the avenue heard the yell and whistle and saw the SUV hit the victim. The backhoe operator, who was bringing a steel plate to the open trench, called 911. The foreman who was also on the west end of the job saw the incident occur and immediately drove his truck into the path of the SUV. He stopped the SUV approximately 200 feet west of the impact area. The police, fire department, and paramedics arrived within minutes and took control of the scene. The victim was transported to a local hospital. He was later transferred to a convalescent hospital where he died as a result of his injuries on August 2, 2004.

According to the police report, the driver of the SUV stated that he was traveling approximately 40 mph in the westbound lane of the avenue when he heard somebody yelling but did not see anyone. He stated that about a second later he felt an impact, pulled over to the side of the road, and saw a work crew. He told police that he saw the work crew dragging somebody over to the south side of the street, at which point he realized he hit someone. He also told police that his windshield wipers were on because it was raining, his front window was slightly fogged-up, and his dome light was stuck in the on position causing a glare on his windshield. He told police he was having some trouble seeing the roadway in front of him, but saw nothing that indicated to him there was construction work in the area.
